RE: Site Inspection, Duchesne County Road Department, Duchesne County Asphalt Mine, M/047/028, Uintah County, Utah

Date of Inspection: April 13, 2000
Time of Inspection: 1005 - 1250
Conditions: Overcast, cool
Participants: Doug Nielson, Duchesne County Road Dept.; Tony Gallegos, DOGM

Purpose of Inspection: To discuss the last Division large mine notice review comments with respect to the response now being prepared by Duchesne County

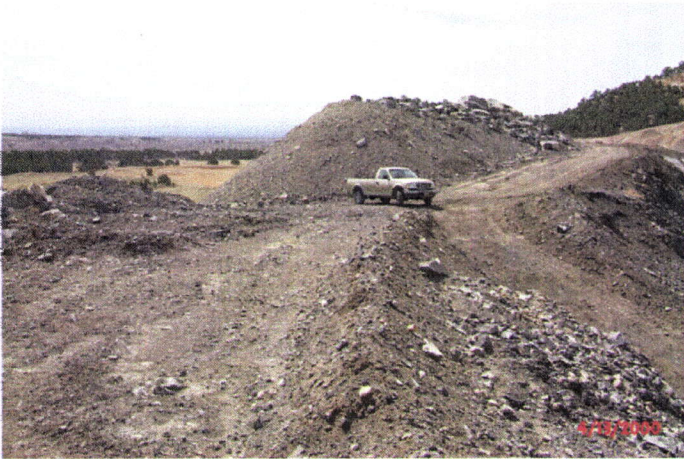
NEW ROAD CUT UP TO
PROPOSED WEST EXPANSION

We then proceeded back down the access road we had driven up. During the construction of this road they encountered a noticeable clay layer just below the topsoil layer. This clay was evident in photos of the road area. Doug explained that the county had put in the upper roads, grubbed the property boundaries and drilled the nine holes between December 1999 and January 2000. Additional photos were taken looking north and south along the grubbed boundary.

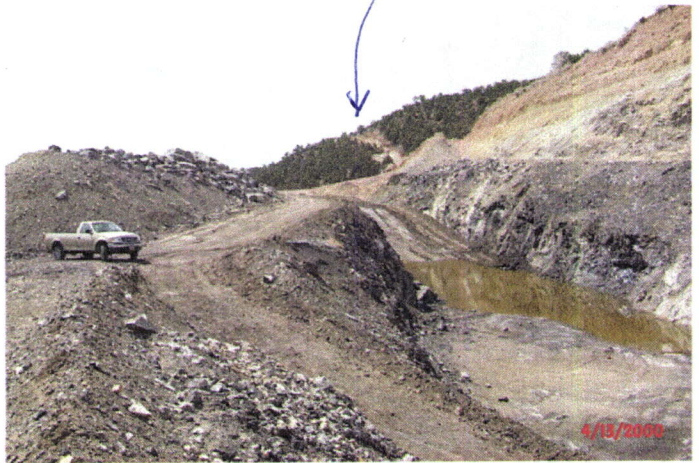
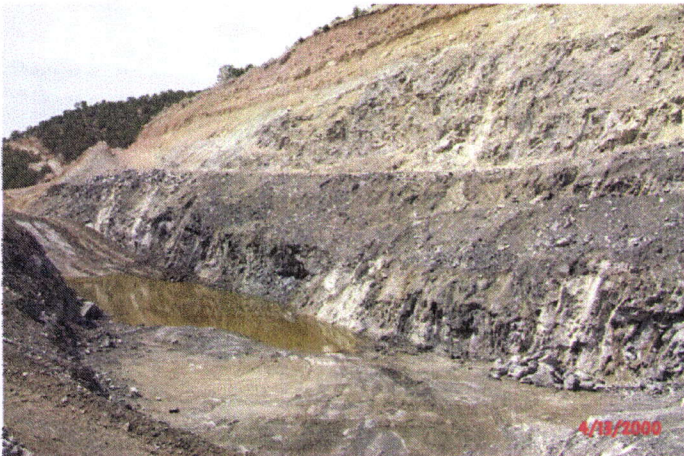
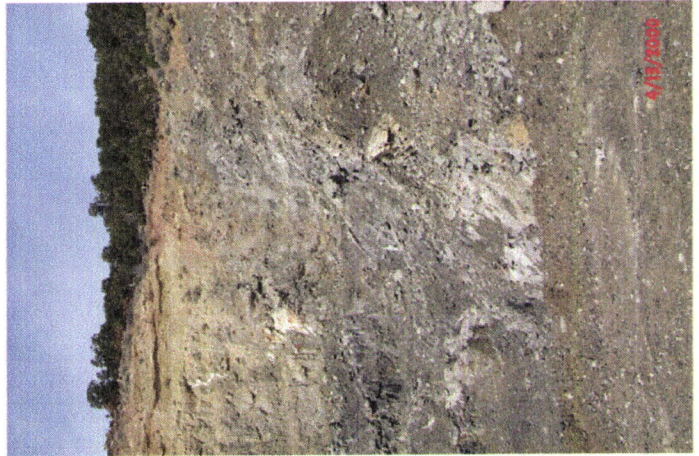
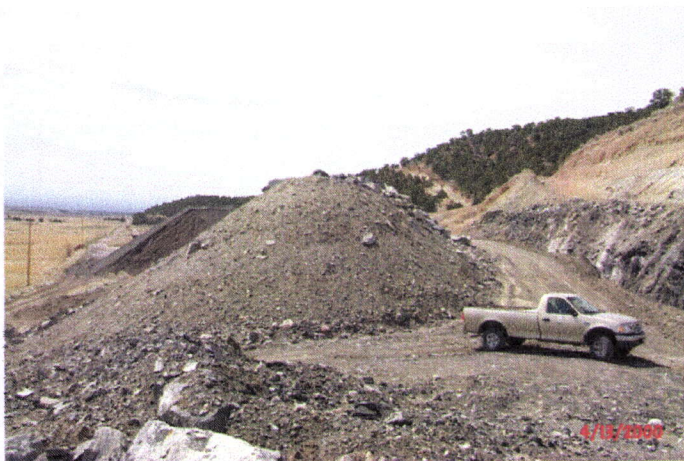
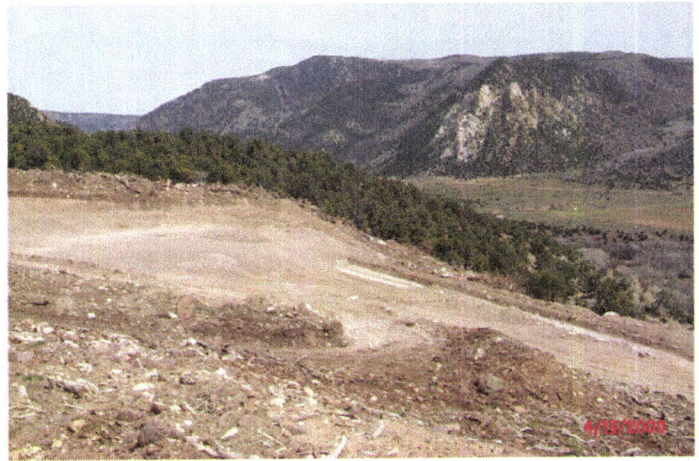
MAIN PIT AREA

Access into the mine site is restricted by a locked gate on the main road. Duchesne County, Bobby Fausett, the USFS, and a private landowner have access through the gate by having their own lock on the chain. We first visited the main pit area. Photographs of the pit looking toward the south include the waste piles to the south and the new road which switch backs up the hill to the proposed expansion area to the west. The roads into the pit showed signs of recent access during a time when the ground was wet judging from the tire ruts. According to Doug Nielson, the County moved out of the pit in April 1999, and since that time they have only been removing material from the stockpile. The County also removed their crusher from the site in April 1999. Any recent mining activity in the pit was probably performed by Bobby Fausett. At this time, Bobby Fausett has an active small mine site located to the south of this main pit.

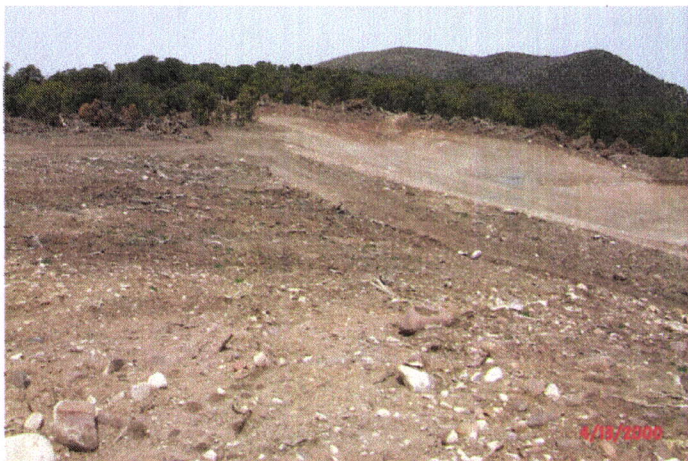
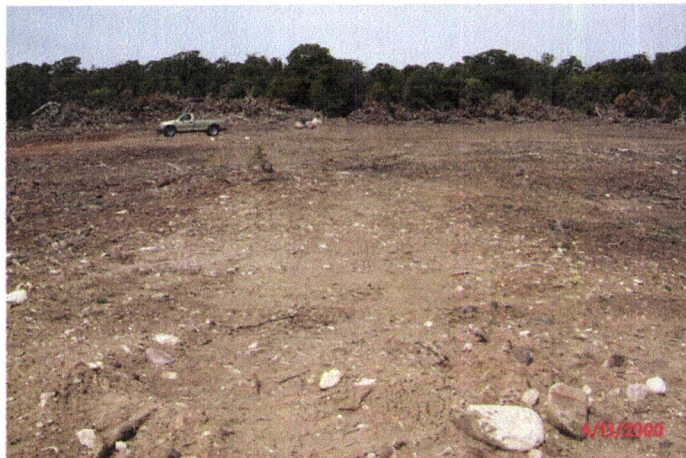
DRILL PAD AREA WEST & ABOVE MAIN PIT

We next drove to the cleared area directly west and above the current pit. From here we first visited the drill hole #2 site. This drill hole has not been plugged and the opening was covered with a rock. The diameter of the hole at the surface is approximately six inches. Photographs were taken of this drill pad area and general vicinity of drill hole #2. A second road connects this upper pad area with the other road.

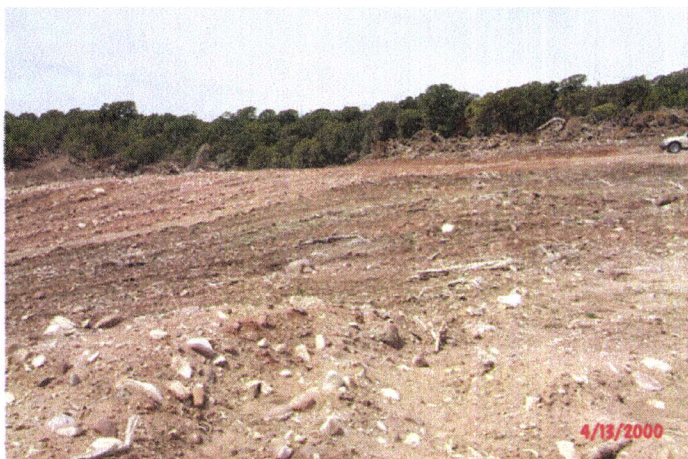
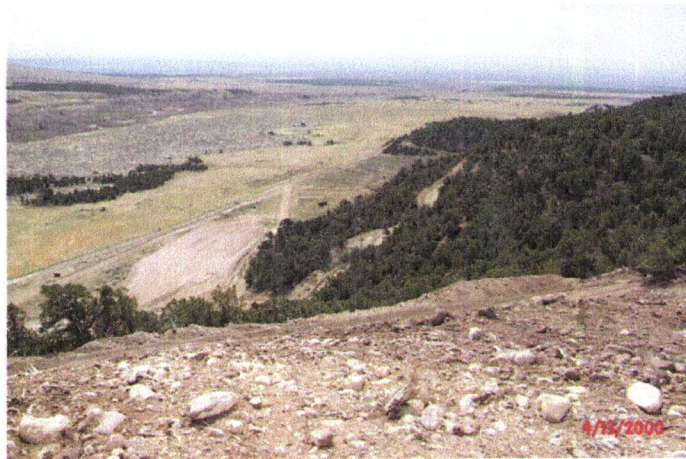
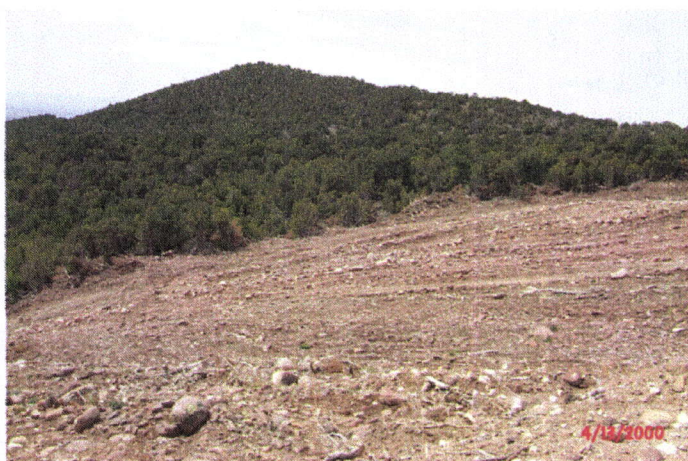
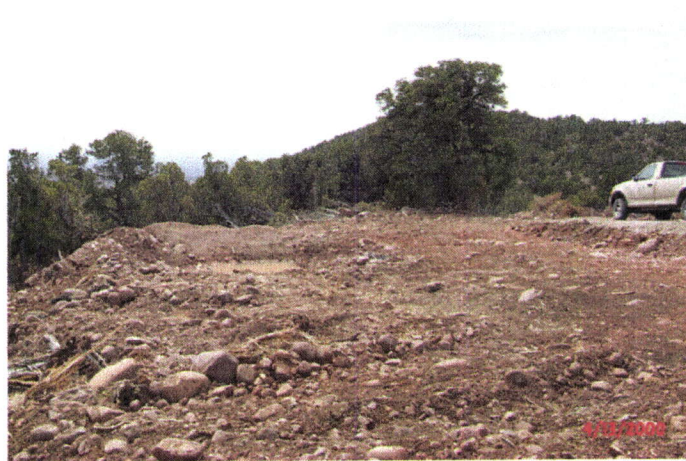
GRUBBED AREA & DRILL PADS IN PROPOSED WEST EXPANSION

I explained that if the County was not going to expand into this area they would need to reclaim the new disturbances including the grubbed boundary line. This boundary line would still be evident years after reclamation, because of the difference in vegetation size and species. Reclamation of the new disturbances would require some regrading, spreading topsoil and slash, and seeding the areas. A key factor in reclamation success is to leave the surface rough, not golf course smooth. The access roads would best be reclaimed by using a track hoe in the steeper sections.

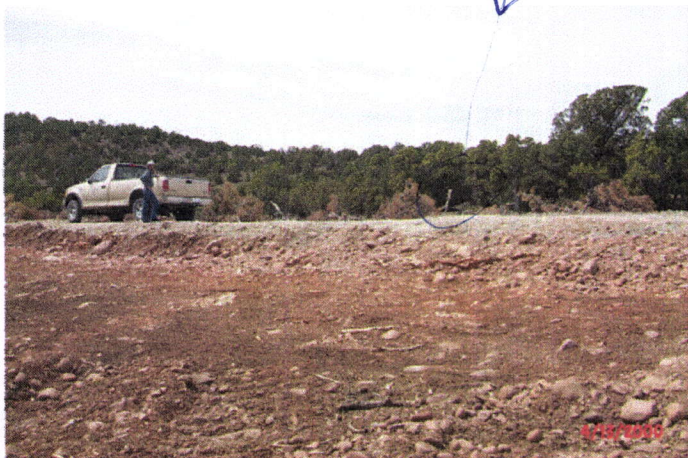
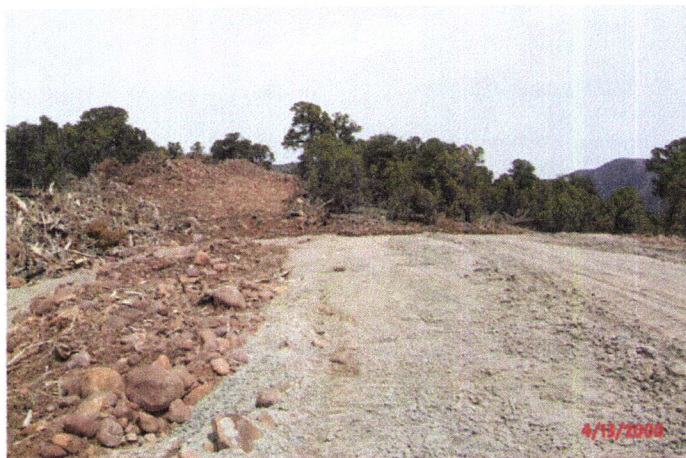
DRILL PIT NEXT TO DRILL HOLE SITE

USFS BOUNDARY SIGN
↓

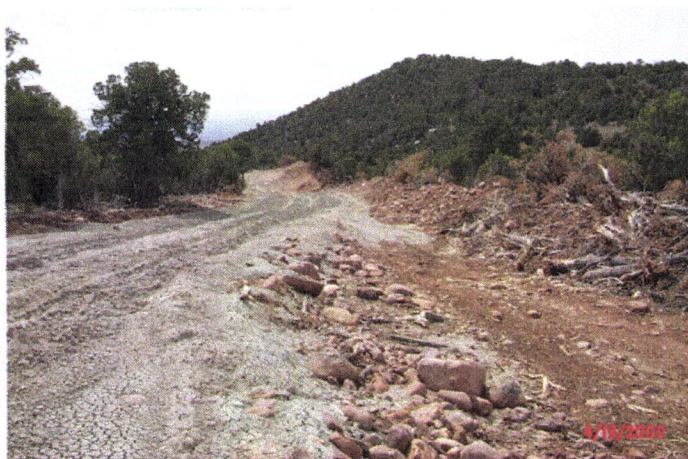
BRUSH CLEARED ALONG PROPERTY LINE
& ACCESS ROAD (NOTE CLAY) - LOOKING NORTH
